# COLD WELDING- THE DREADED WORD IN IMPLANT DENTISTRY- A CASE REPORT

*AIM: To illustrate a new technique to retrieve the cold welded cover screw*

*CASE REPORT: This case report describes how a cold welded cover screw was successfully removed with the help of a screw driver.*

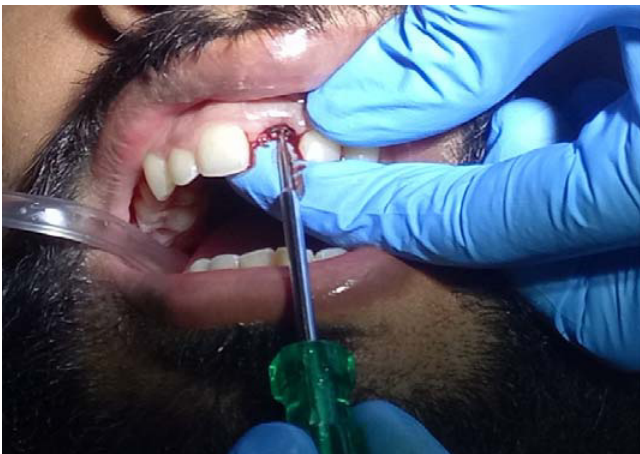
Fig1:Removing cold welded cover screw using screw driver

After three months, an iopa was taken to evaluate the degree of osseointegration. As good osseointegration was achieved, a second stage surgery was planned and during the procedure ,it was found that due to cold welding, it was impossible to remove the cover screw. Applying cold ice and using an ultrasonic scaler was tried out unsuccessfully to remove the cover screw. Finally it was decided to create a slot on the surface of the cover screw with a tapered fissure diamond bur (width of 2mm and depth of 1mm) after which a screw driver of appropriate size (2mm width) was used . Screw driver was engaged in to the created

slot and was turned in an anticlockwise direction. Cold welded cover screw was successfully removed from the implant. During procedure care was taken not to damage the implant threads and a slot not exceeding a depth of 1mm was created on the surface of the cover screw.

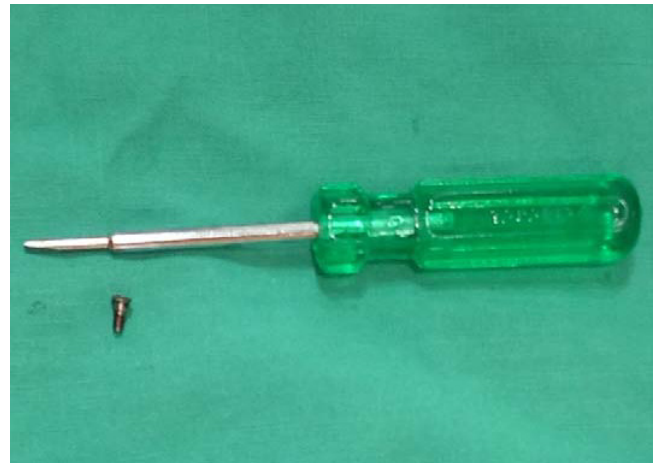
Fig2: Retrieved cover screw and screw driver

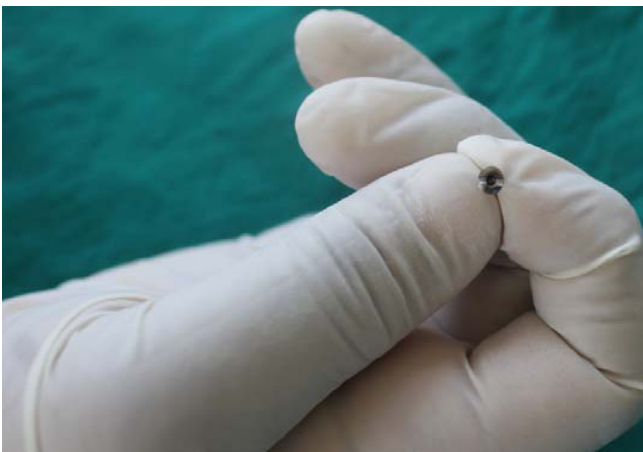
Fig3: slot created in the cover screw

Different methods like application of ice, using ultrasonic scaler etc could not remove the cold welded cover screw. So a slot was created on the surface of the cover screw and an appropriate screw driver was used to remove it.

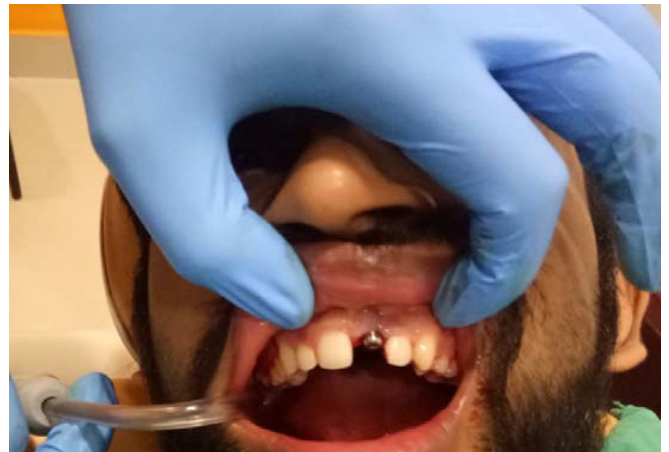
Fig4: Gingival former placed

Abutment was placed and fit of the abutment was verified clinically and radiographically. Healing abutments were placed, after thorough irrigation of the area.
