# MANAGEMENT OF IMPLANT SCREW LOOSENING -A CASE REPORT

## Abstract

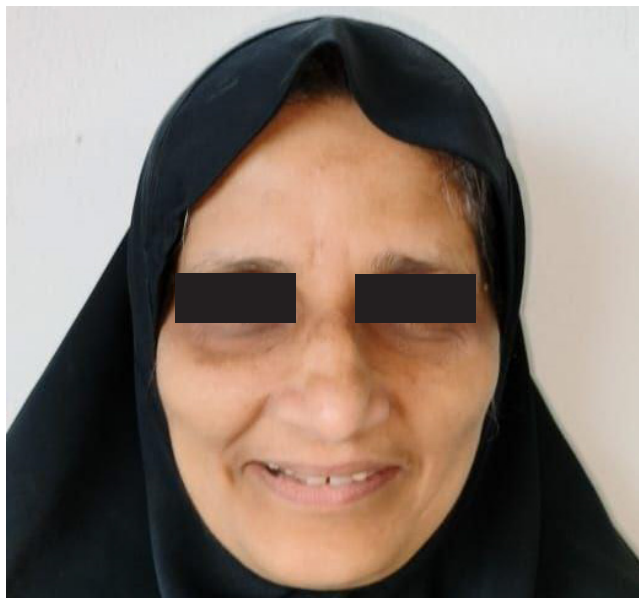
Fig. 1 – Pre-Operative photograph

A 45 year old female patient reported to The MAHE Dental College, Department of Prosthodontics with a chief complaint of dislodged implant crown and misfit implant crown in the right lower back tooth region. (Fig. 1)

On examination, implant crown in 47 was dislodged and the implant crown in 46 was rotated. RVG was made and the radiographical assessment

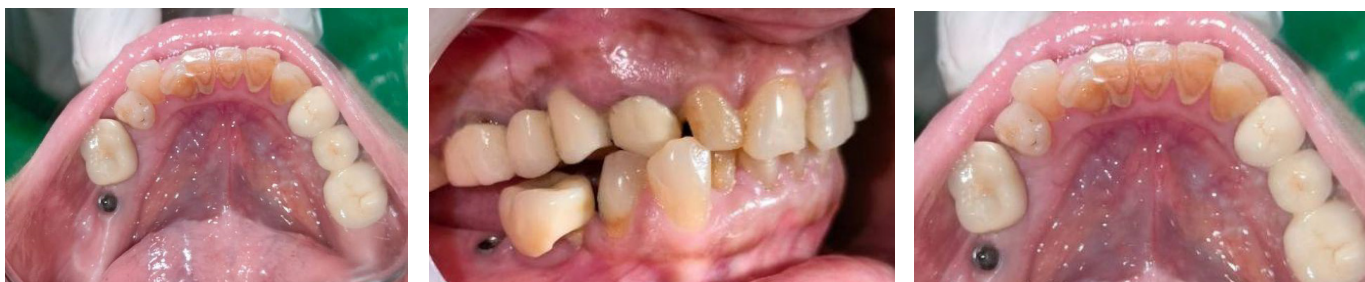
Figure 2 a,2b,2c – Pre-Operative Intraoral Photographs

revealed discrepancy between the transmucosal abutments and the fixture head which indicated implant abutment screw loosening in 46 and dislodged crown in 47 (Fig. 2a,2b,2c). Both the implant prosthesis were screw retained. (Fig. 3)

This case report illustrates one of the mechanical complication which can occur during prosthetic stage of implant surgery. The radiovisiography revealed discrepancy between the transmucosal abutments and the fixture head which indicated implant abutment screw loosening in 46 and dislodged crown in 47. The reason for screw loosening was due to inadequate application of tightening torque to generate the necessary preload. The screw loosening of implant abutment can cause issue for both the dentist and patient .It is essential to sacrifice the overlying restoration to give access to the screw. Screws have been studied considerably in the engineering literature and dental implant screws have been improved as a result.

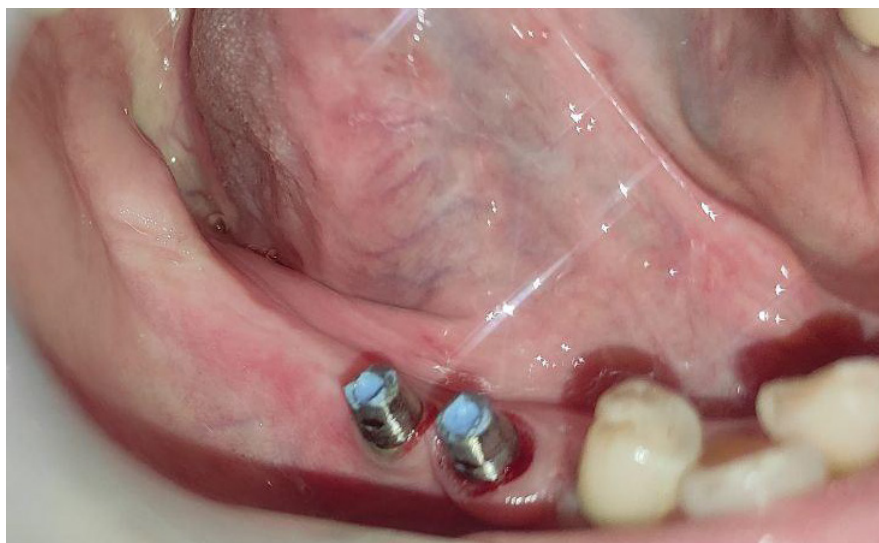
Fig.4 – Straight abutment placed in 46 And 47 region and access holes packed with putty impression material

Suitable straight abutment were screwed and adequate preparation was done. After acquiring adequate clearance, the access holes were packed with putty impression material and an abutment level impression were made using addition silicone and light body for fabricating a splinted cement

retained implant prosthesis in 46 and 47 (Fig.4, Fig.5).
