The journal of PROSTHETIC AND IMPLANT DENTISTRY

RETRIEVAL OF A COLD WELDED GINGIVAL FORMER - A CASE REPORT

CASE REPORT: This case report describes how a cold welded gingival former was retrieved without damaging the threads of an implant.

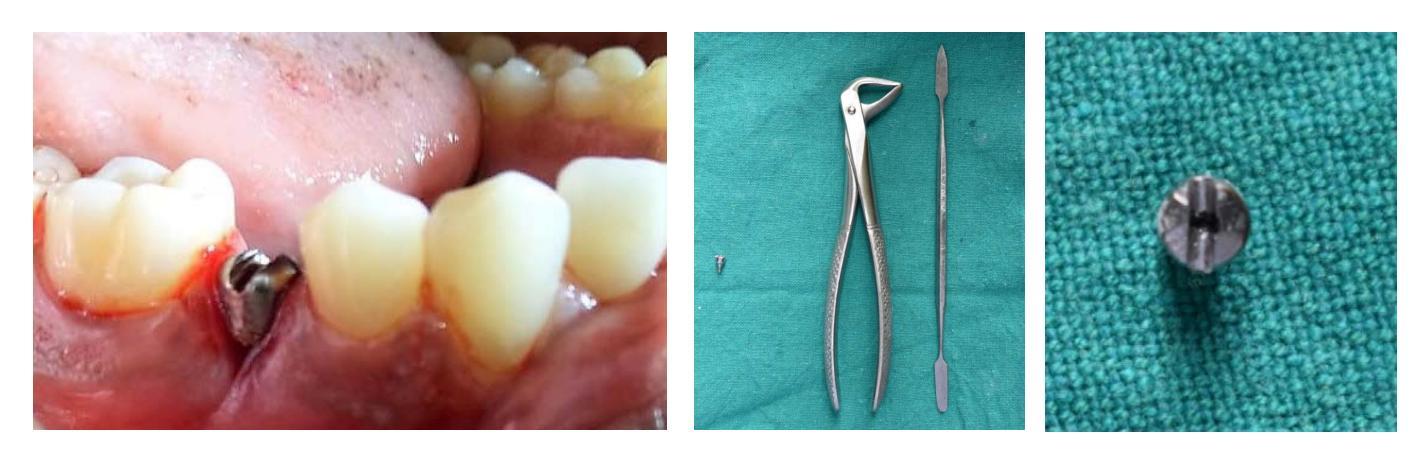
During prosthetic phase hex driver was engaged into the gingival former of the implant and unscrewing of gingival former was attempted multiple times. Since it did not loosen a manual ratchet was used to retrieve the gingival former by applying reverse torque of greater than 35Ncm. Friction slot of gingival former was worn out because of repeated trial. The drilling of the gingival former had a high risk of damaging the internal threads of the implant. So drilling the body of gingival former was aborted.

Using a high speed handpiece extensions were made on the gingival formers from the center to both end with carbide bur. The flat end of a cement mixing spatula was engaged and turned the gingival former in an anticlockwise direction still no change happened. Lower anterior forceps with fine beaks were used to hold gingival former firm apical pressure was applied followed by anticlockwise movement until the gingival former was retrieved. The implant threads were well preserved. Thorough betadine irrigation was done. A new gingival former was placed.

Though a notch was created over the gingival former to retrieve it using a cement spatula, it was not successful. Hence extraction forceps with fine beaks were used to turn it anticlockwise. This technique is cost effective, simple and applicable to all available dental implant system. This can be incorporated where the retrievability of the coldwelded gingival formers are difficult. However there is a possibility of applying injudicious force while removing it and care should be taken not to disturb the osseointegrated implant.
